Adobe's Mechanical Characterization in Ancient Constructions: The Case of Aveiro's Region

Tiago Martins^{1,a} and Humberto Varum^{1,b}

¹Civil Engineering Department, University of Aveiro, 3810-193 Aveiro, Portugal

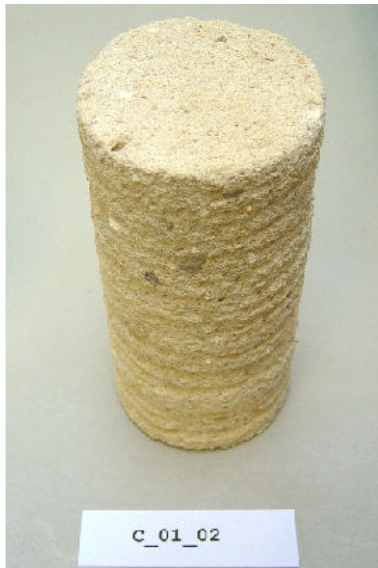
Fig. 1 – House specimen

Cylindrical specimens were extracted from three different constructions in adobe. One series of specimens were extracted from a small (Fig. 1) house and the other two series were extracted from two walls (Fig. 2 and 3). The constitution of these three adobe's are significantly different, and consequently the strength also reflects that, as will be presented in the test results.

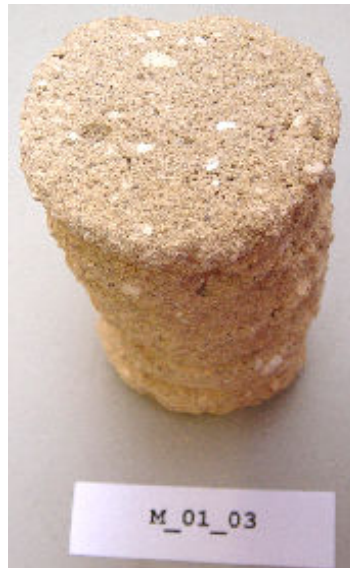
Fig. 2 – Wall 1 specimen

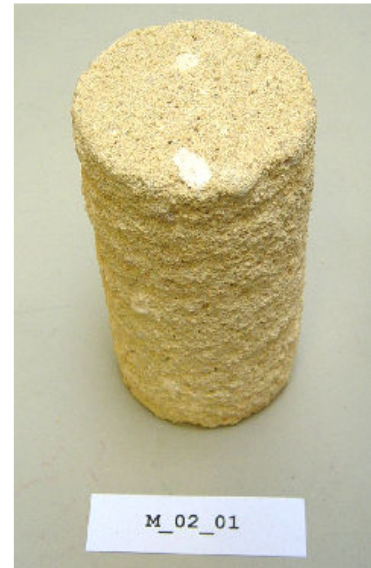
Fig. 3 – Wall 2 specimen

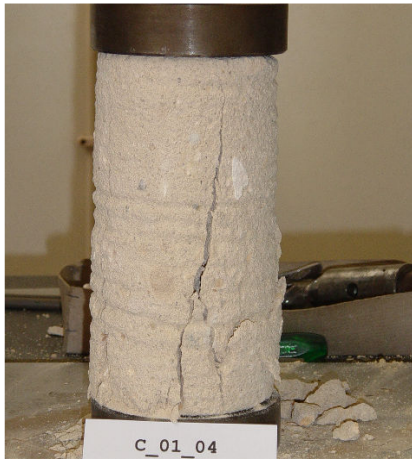
Fig. 4 – Compression tests

The specimens were divided in two groups, one to perform the compression tests (Fig. 4), and the other for the diametral compression tests (Fig. 5).

Due to adobe standard mechanical tests' inexistence, it were followed the RILEM technical recommendations for concrete specimen tests [4], to evaluate the compressive and tensile strength of the adobe specimens. The compressive strength was determined from the failure compression load divided by the specimen area resisting to the load and reported in units $[N/mm^2]$, as described in RILEM CPC4. The compressive strength is commonly used in the safety assessment and design of constructions.
